Camp Thunderbird Upgrades DETAILED MITIGATION PLAN, REVISED

Pacific Harbor Council, Boy Scouts of America
February 2023

February 2023

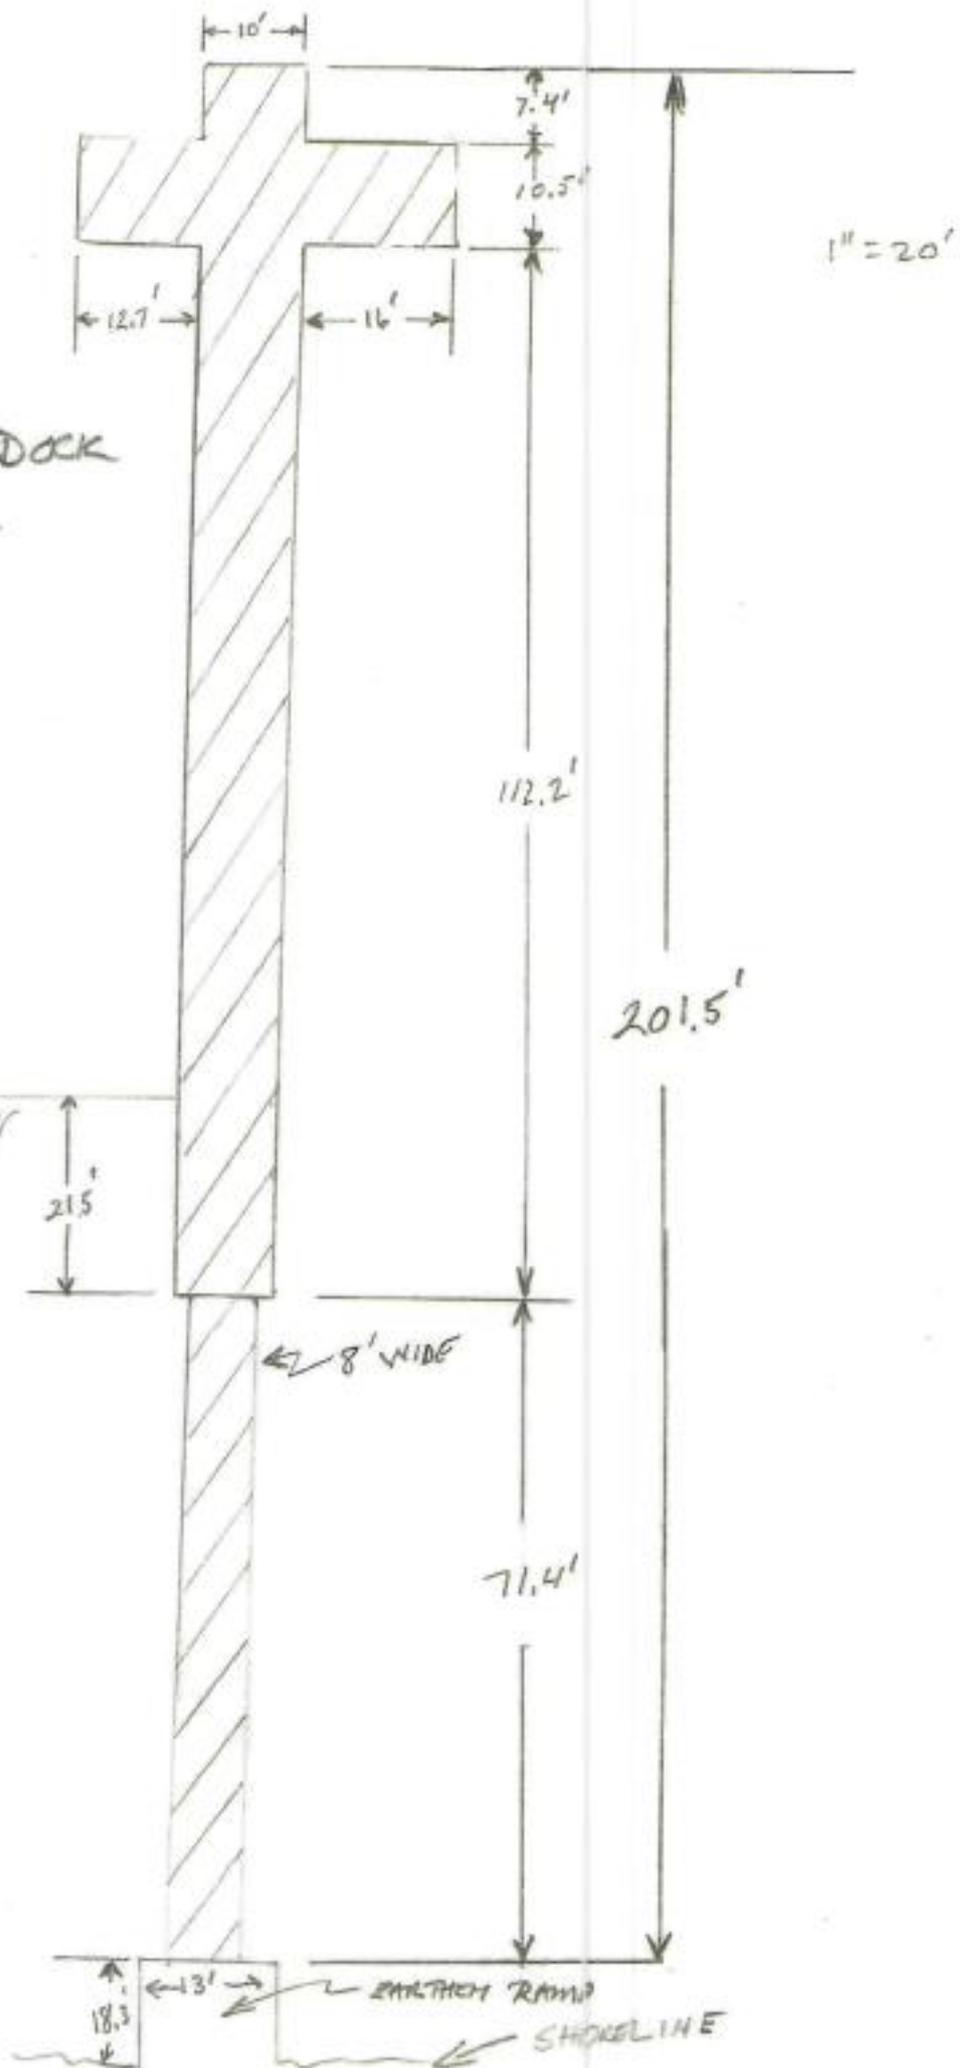
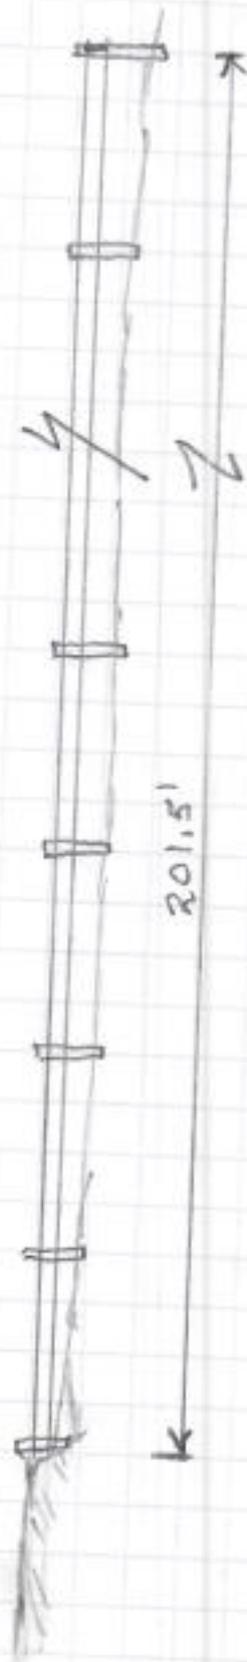
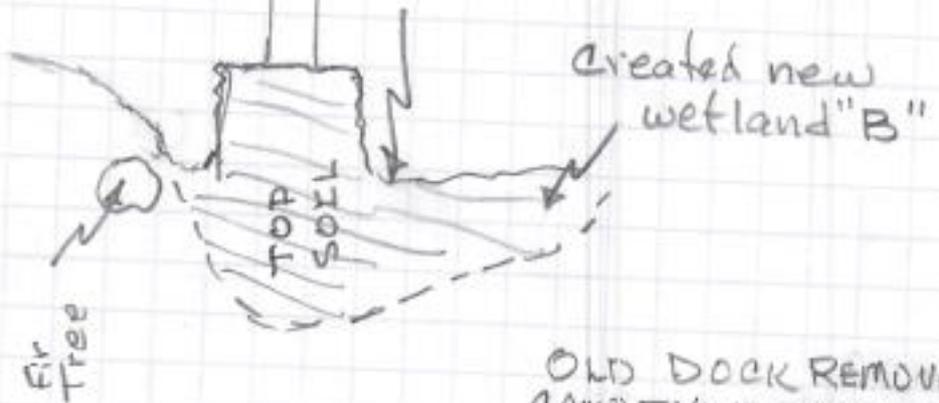
OLD DOCK REMOVAL
 CAMP THUNDERBIRD
 WETLAND B
 CONSTRUCTION
 RLW - NOV 28, 2022

EXISTING BOIFT DOCK
TO BE REMOVED.

REMOVE 890 sf of TOP SOIL
 AVERAGE of 2.0 ft deep = 82,4 cy

- 1) Remove TOP SOIL to 6" Below normal Lake level
- 2) slope new shoreline 1 to 3 1/3
- 3) Plant created wetland Per Report
- 4) Remove old dock deck and cut off dock piles at mudline

A total of 1,534 square feet (1.24:1 ratio) of wetland will be created. Specifically, 890 square feet of fill will be removed from Wetland B in the vicinity of the existing dock. Some of this fill is the earthen ramp that connects the existing dock to land. An additional 644 square feet of wetland will be created through the removal of upland soils adjacent to Wetland C.

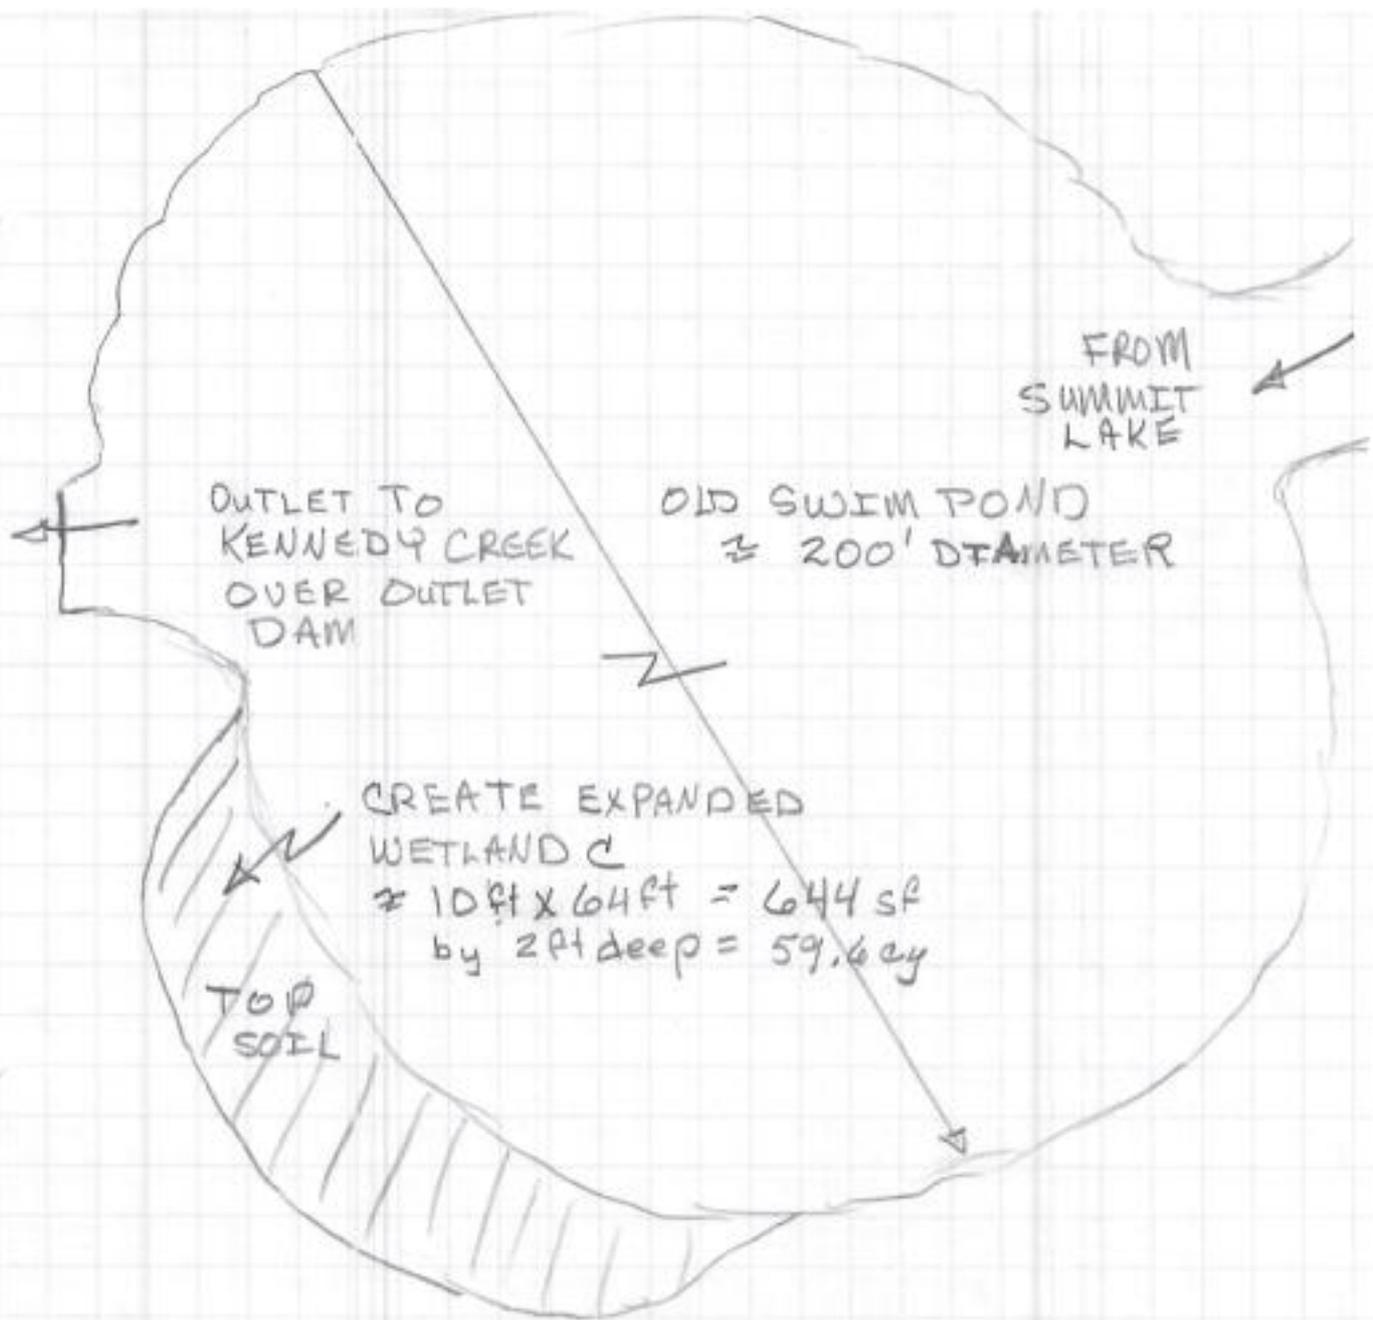
SWIM POND WETLAND C
 CAMP THUNDER BIRD
 WETLAND C
 CONSTRUCTION
 RLW - NOV 28, 2022

- 1) Remove TOP SOIL to 6" Below normal lake level
- 2) Slope new shore line 1 to 3 1D
- 3) Plant created wetland per Report³
- 4) Remove old docks & floats from pond

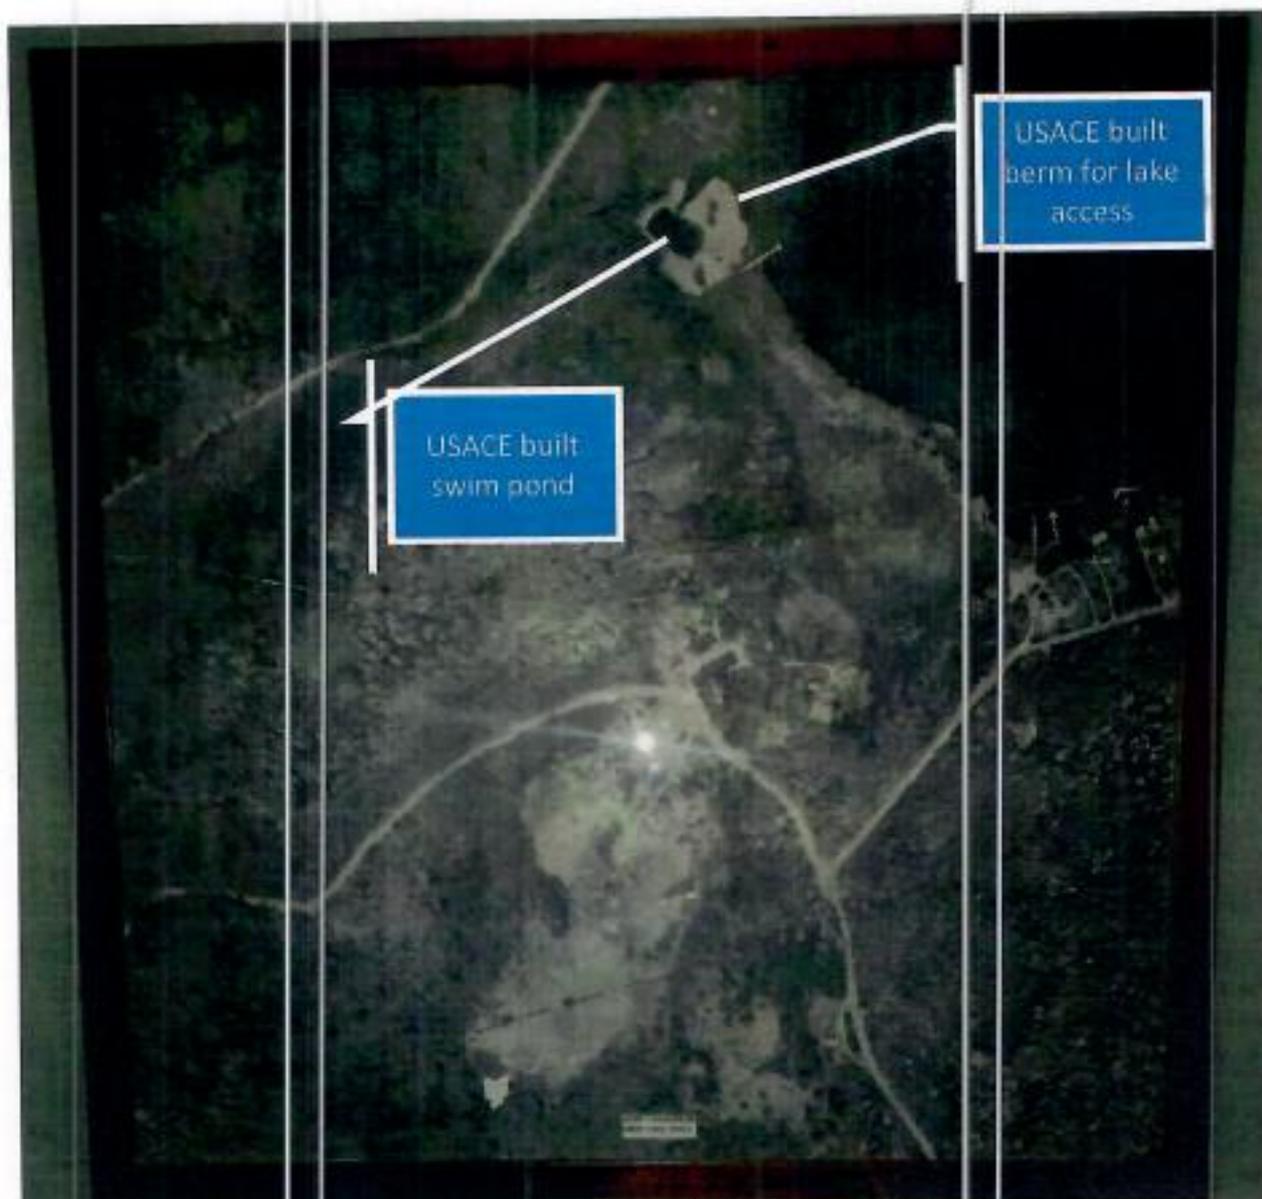
Figure 5) Annotated photo of a wall hanging photo of the camp area, late 1960s.

The Army Corp of Engineers undertook a project in the mid 1960s to build a swimming area in the Kennedy Creek outfall and to build a land berm for lake boating access. That swim area is seen in Figure 1. The constructed berm is the area east of the swim area where the single canoe can be seen.

No other significant earthworks have been completed but a significant amount of maintenance and upkeep work has gone on over the decades. The primary issue has been the quality and size of the swimming area. It has been limited to primarily a recreational swimming area as it was not a good area for the programmatic elements of the scouting aquatic program. It did not provide the distances, depth, or water clarity needed for successful execution of a top-notch scouting swim or aquatic program.

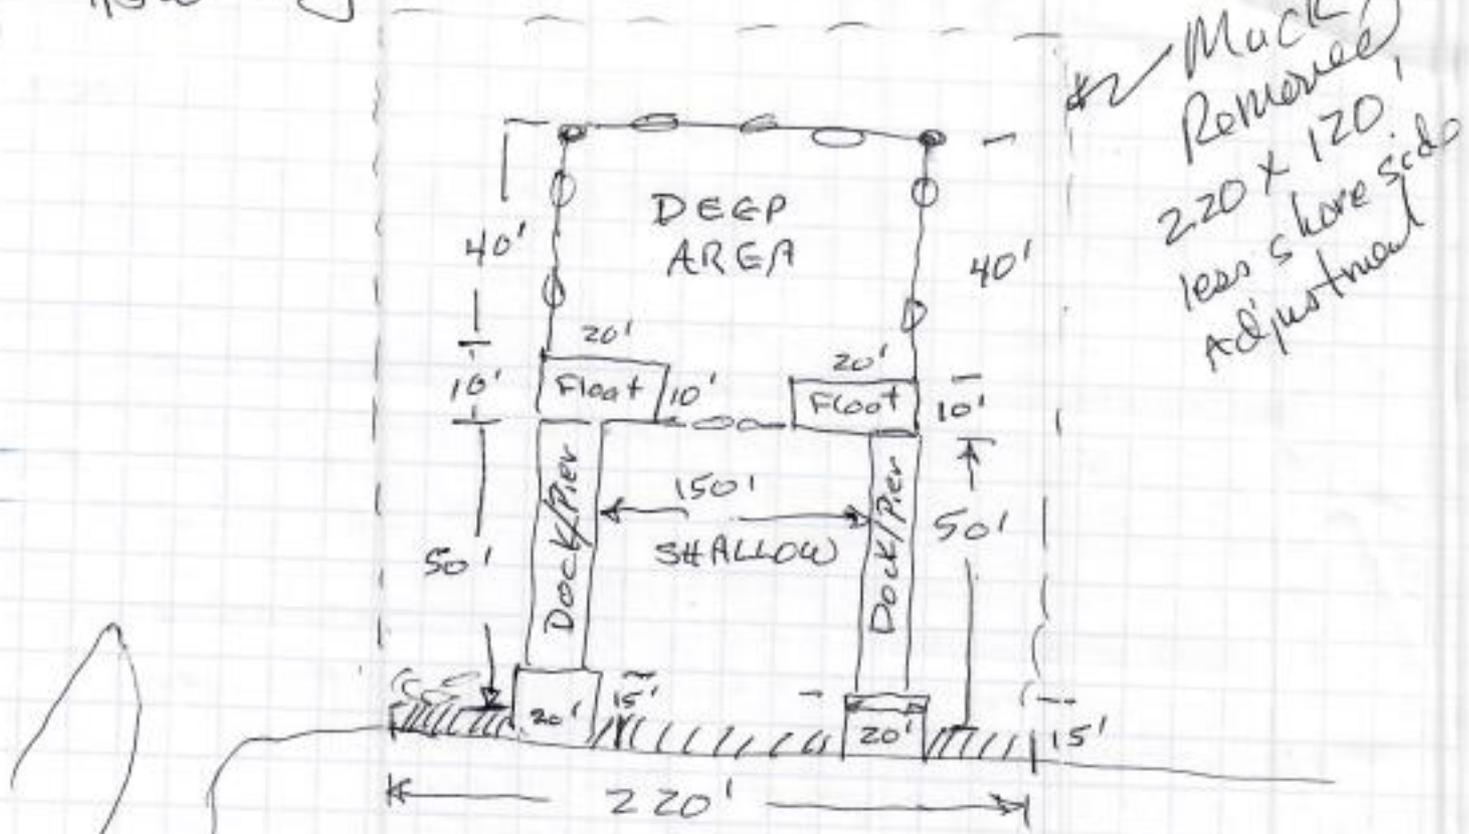
Muck Removed
220 x 120
less shore side
adjustment

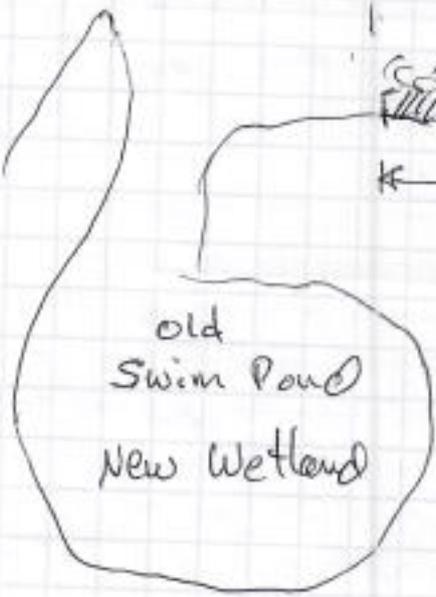
Note County/Ecology Suggests

- 1) Protect Wetland Plants in 1st 10' from shore & mitigate the 2 entry areas. cleared 2x(15' x 20) = 600 SF - the rest of the shoreline plants left undisturbed
- 2) Noxious water lilies in remainder of 220 x 120 area that has muck removed requires minimal mitigation
- 3) Old swim pond now available a high quality mitigation per earlier mappings
- 4) Remove old boat dock high value mitigation
